Manhole Inspection Summary

Manhole # S07AA2005MH

Location Address: **2711 GLEN AVE** Cross Street: **BERKELEY AVE**

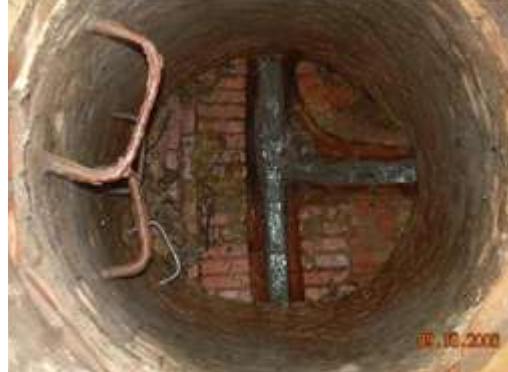
Top View

Corroded steps. Evidence of surcharge - Bench debris. Grease in the Channel.

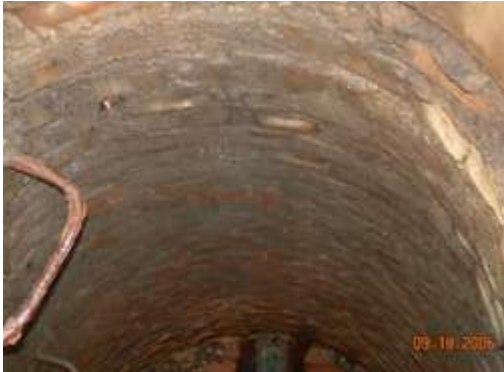
Defect

Frame Offset: **0** (in.) Condition: ☐ Sound ☐ Cracked ☒ **Leaks**

Chimney / Frame Adjustment ☒ Exists Material: **Brick** ☐ Parged Height: **4** (in.)
Condition: ☐ Sound ☐ Cracked ☐ Root Intrusion ☐ Loose Brick ☒ **Deteriorated**
Infiltration: ☐ None ☒ **Joint** ☐ Cracks ☒ **Mortar** ☐ Roots ☒ **Wall**

Corbel Material: **Brick** ☐ Parged Type: **Concentric/Eccentric**
Condition: ☒ Sound ☐ Cracked ☐ Root Intrusion ☐ Loose Brick ☐ Deteriorated
Infiltration: ☐ None ☐ Joint ☐ Cracks ☒ **Mortar** ☐ Roots ☒ **Wall**

Frame leaks. Adjustment deterioration and infiltration. Corbel infiltration.

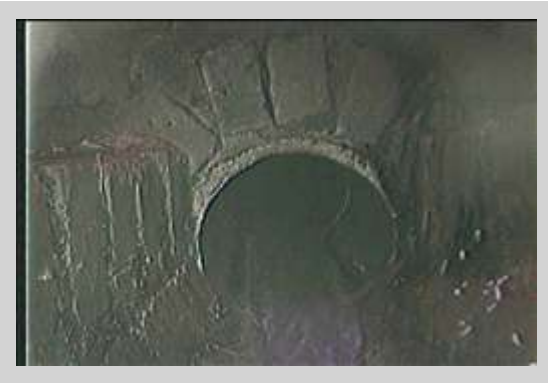
8 in. Circular Gravity Sewer Pipe Out @ 12 O'Clock

Barrel Material: **Brick** ☐ Parged
Shape: **Circular** Diameter: **42** (in.) Length: (in.)
Condition: ☐ Sound ☐ Cracked ☐ Root Intrusion ☐ Loose Brick ☒ **Deteriorated**
Infiltration: ☐ None ☐ Joint ☐ Cracks ☒ **Mortar** ☐ Roots ☒ **Wall**

Barrel deterioration and infiltration.

Infiltration: **Evidence** Pipe Seal Cond: **Unknown**

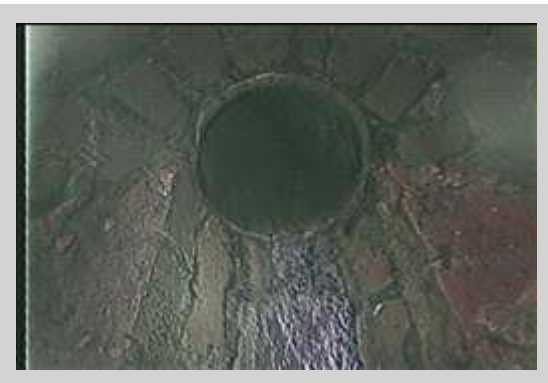
8 in. Circular Gravity Sewer Pipe In @ 3 O'Clock

Infiltration: **Evidence** Pipe Seal Cond: **Unknown**

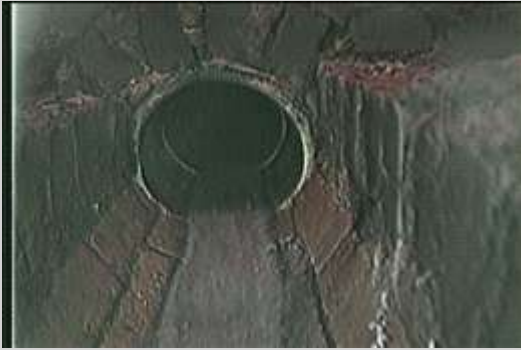
Pipe In @ 6 O'Clock

Channel Material: **Brick** ☐ Parged ☐ Debris (not Condition related)
Channel Exposure: **Fully Open** Junc Dist: **0** nearest .5 ft. Azimuth:
Condition: ☐ Sound ☐ Cracked ☐ Root Intrusion ☒ **Deteriorated** ☐ Leaks ☐ Debris

Channel deterioration.

Infiltration: **Evidence** Pipe Seal Cond: **Cracked**
